# Manhole Inspection Summary

Manhole # S43E\_\_052MH

Insp Date: **7/29/09 11:36 AM**

**Location** Address: **11 DALLAS-BETHEL-ALLEY** Cross Street: **E BALTIMORE ST**

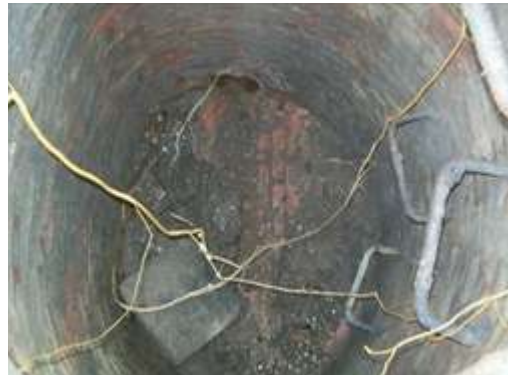
Top View

OPENNED WITH 16LB MAUL

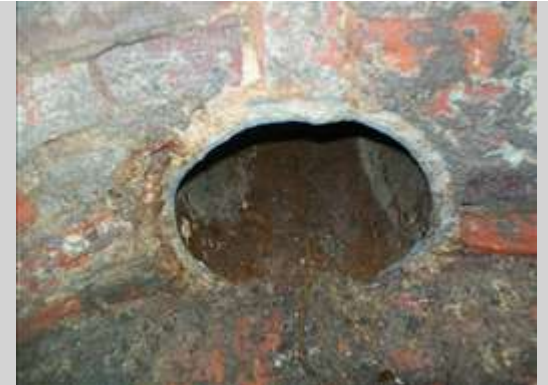
12 O'Clock Outflow

8 in. Circular Gravity Sewer  
Pipe Out @ 12 O'Clock

Pipe Height: **8.4** (in.) Rod and Bar (Angled)

Pipe Material: **Clay** ☐ Pipe Lined

Infiltration: **None** Pipe Seal Cond: **Sound**
